**Buyer's Choice Home Inspections**  
**The Best Home Inspection At The Best Price**  
7403 w Fargo Dr.  
Peoria, AZ 85382  
Tel 480-250-1136 Mobile (480) 250-1136  
Web [www.inspectazhomes.com](http://www.inspectazhomes.com) Email [info@inspectazhomes.com](mailto:info@inspectazhomes.com)

## Confidential Inspection Report

**15848 N 136th Ln**  
**Surprise, AZ 85374**

**02/18/2017 08:00 AM - 11:30 AM**

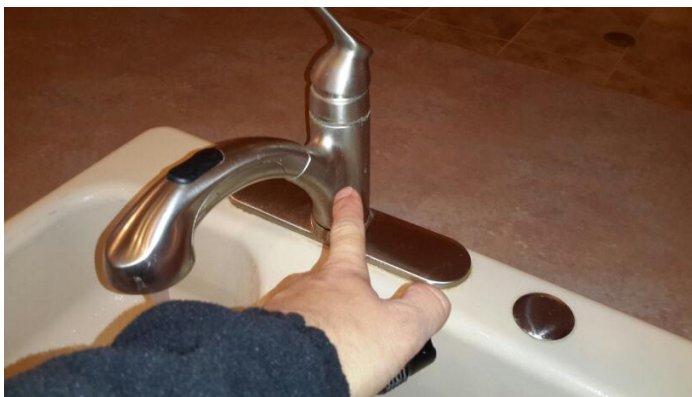
1.8 - The kitchen faucet is hard to rotate and repair is recommended.

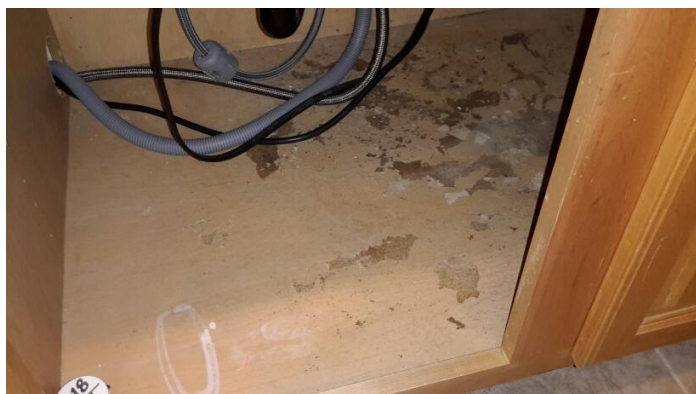
1.20 - The kitchen floor of the sink cabinet is functional but moisture stained or moisture damaged. I recommend you should view this and correct as desired.

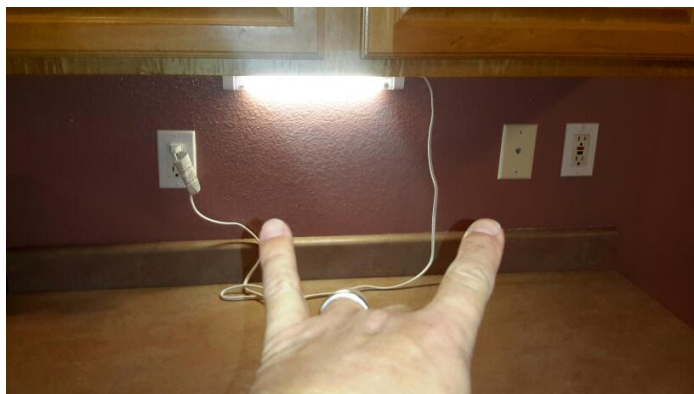
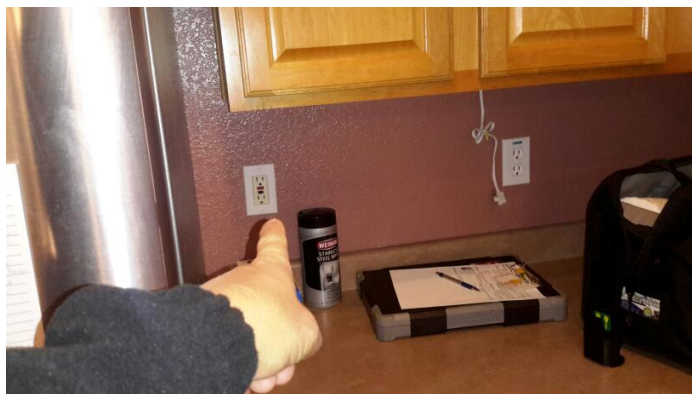
1.26 - There are multiple gfci outlets on the same circuit which is redundant and you may want to have it reduced to the minimum. Further evaluation recommend.

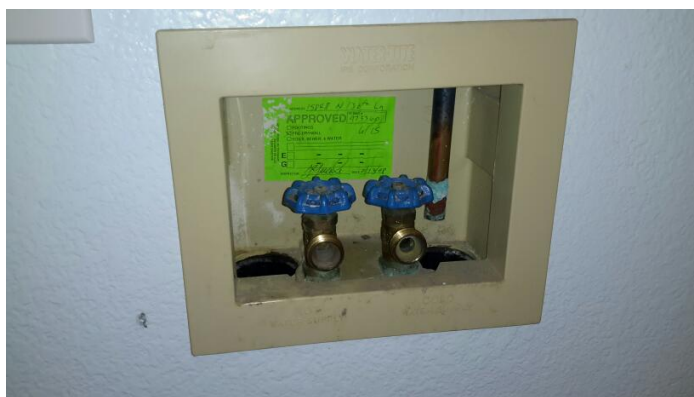
2.10 - The washing machine valves are older gate style valves. These valves are prone to failing and leaking as they age, especially if they are older. Since washing machine valves are rarely used, I recommend using caution when turning them on or off, as leaking may occur. To avoid possible leaking or valve failure, I recommend replacing these gate valves with newer ones.

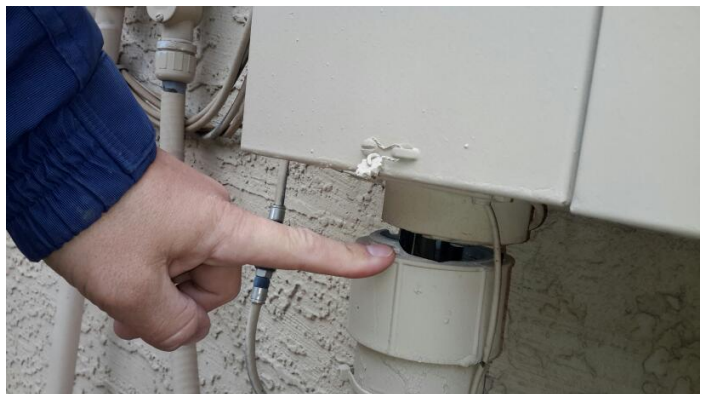
6.3 - The conduit that covers the main conductor lines is cracked, beneath the panel box, which leaves exposed live wires. Further evaluation is recommended for safety reasons

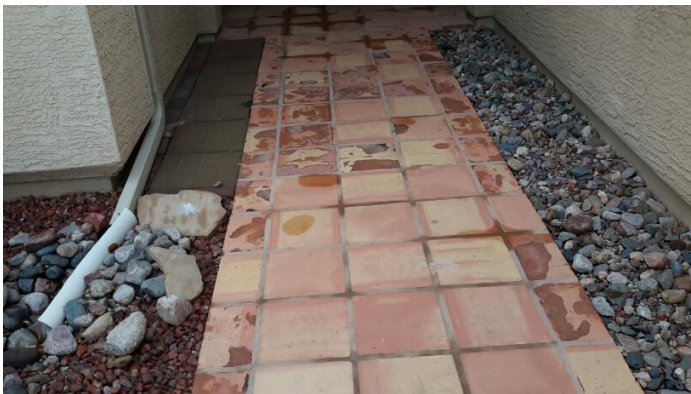
8.4 - The front walk way is pitted and cracking which you may want repaired.

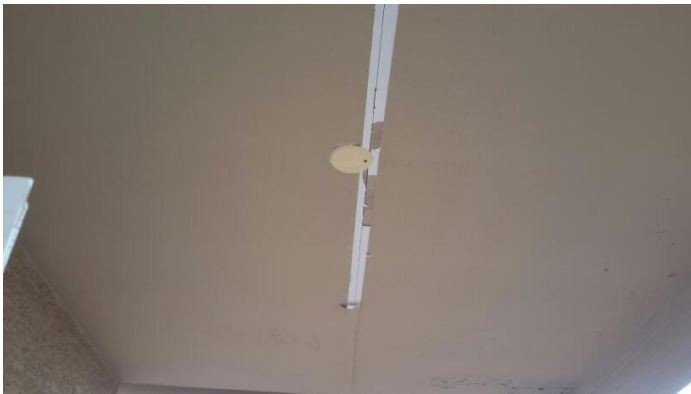
8.6 - There is minor drywall damage to the rear patio ceiling that you may want repaired.

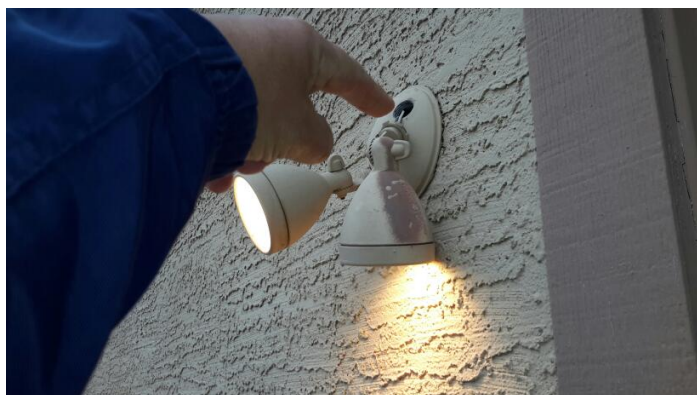
8.10 - The light for the garage side door is hanging and should be repaired as necessary.

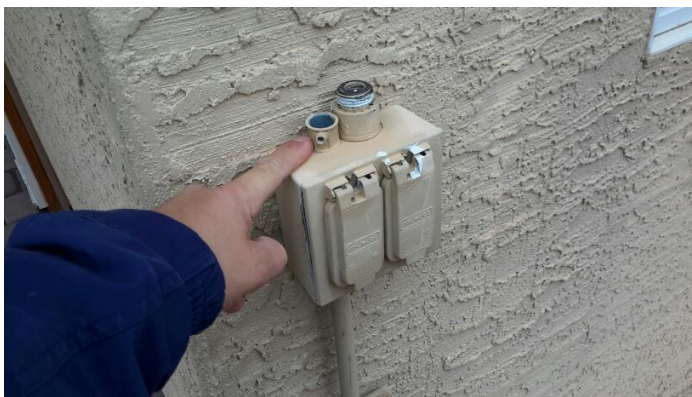
8.11 - The exposed box by the rear patio should be capped to prevent moisture intrusion.

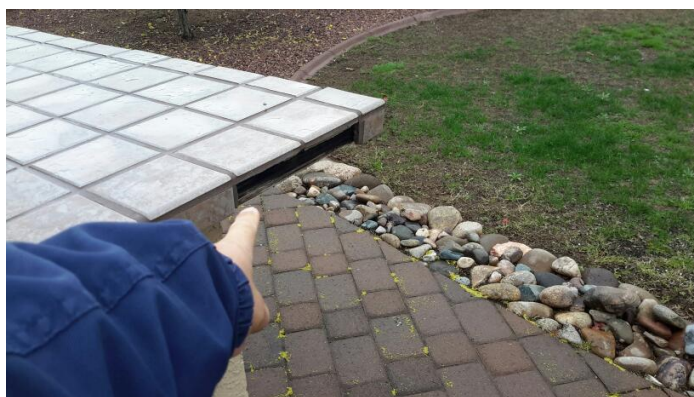
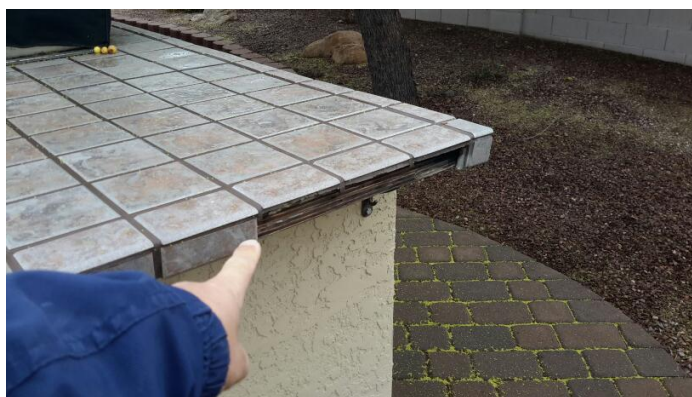
8.14 - The counter top has cosmetic damage which would not necessarily need to be serviced. I recommend you should view this countertop and service it as you feel necessary.

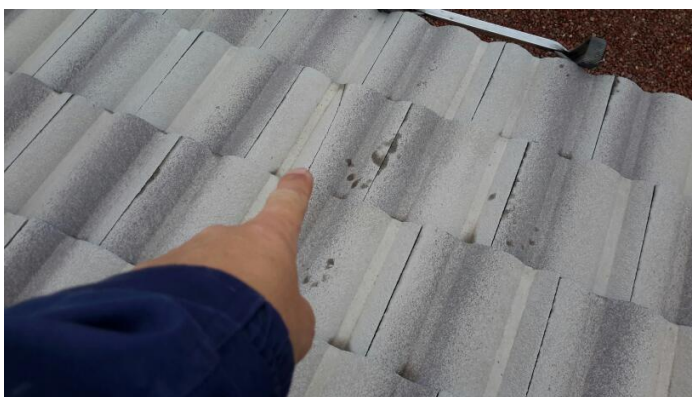
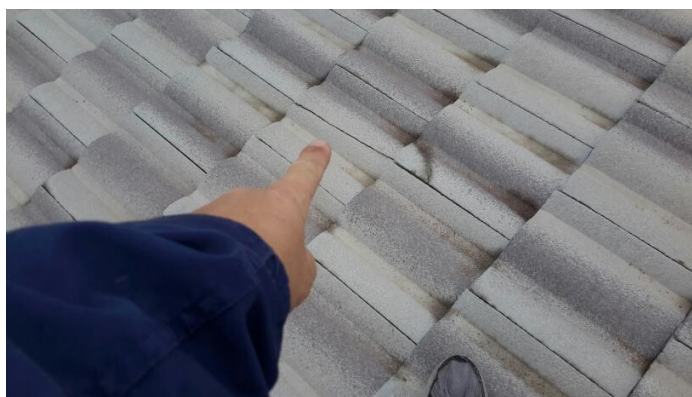
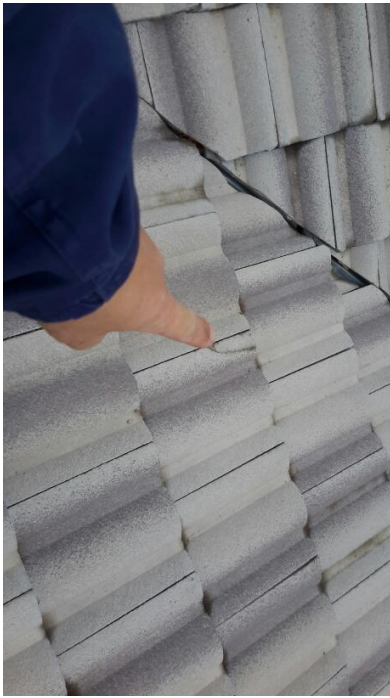
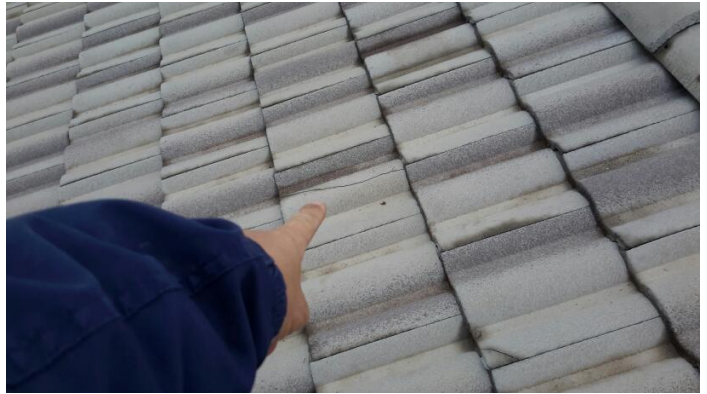
9.3 - Viewed at least 4 cracked roof tiles that should be evaluated and repaired or replaced as necessary by a qualified roofer or technician. These issues should be repaired to help prevent wearing of the protective layer beneath the roof covering or possible moisture intrusion within the residence. Over garage.

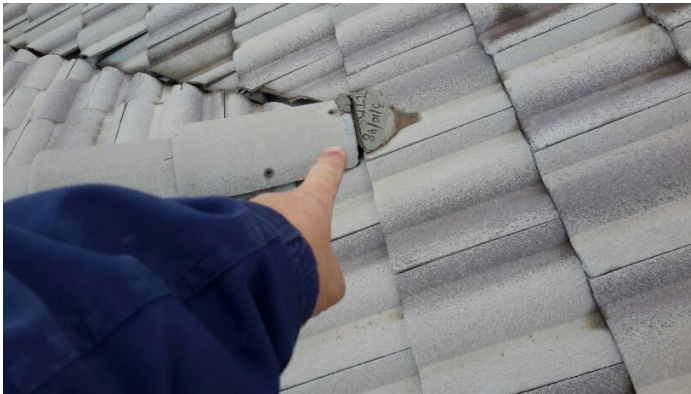
9.4 - I recommended having the cracked roof mortar caps evaluated and serviced as necessary or the roof could leak.

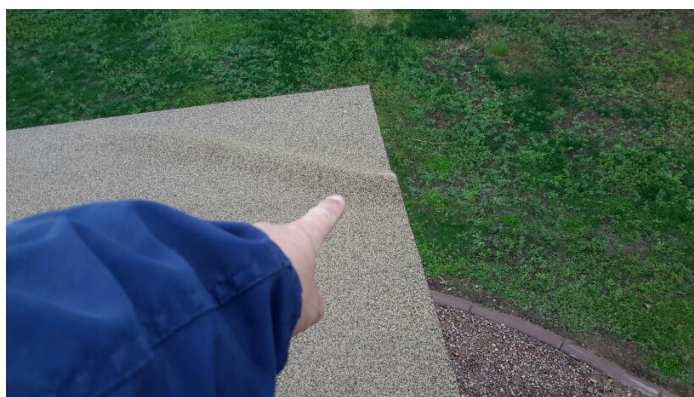
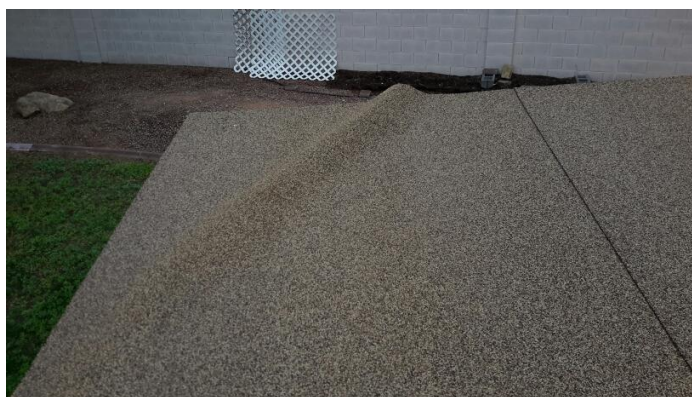
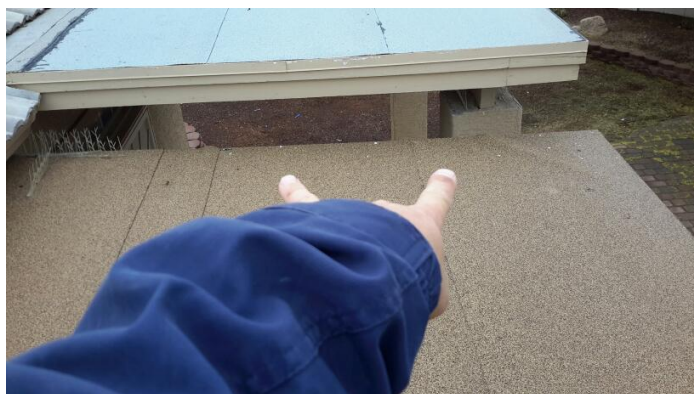
9.5 - The roof has a flat-roofed addition, and flat roofs can be problematic if they are not maintained. Water will pond on most of them, and only be dispersed by evaporation, and they must be kept clean and inspected regularly. However, this flat roof needs serviced for the following reasons: rolled edge and further evaluation is recommended.

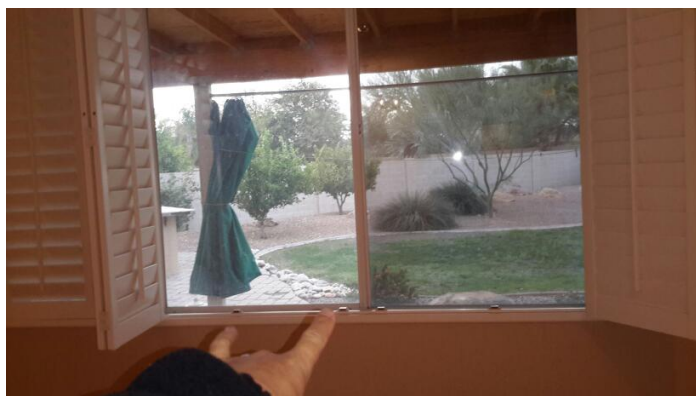
10.4 - One family room window does not work properly and needs service close properly and further review is recommended.

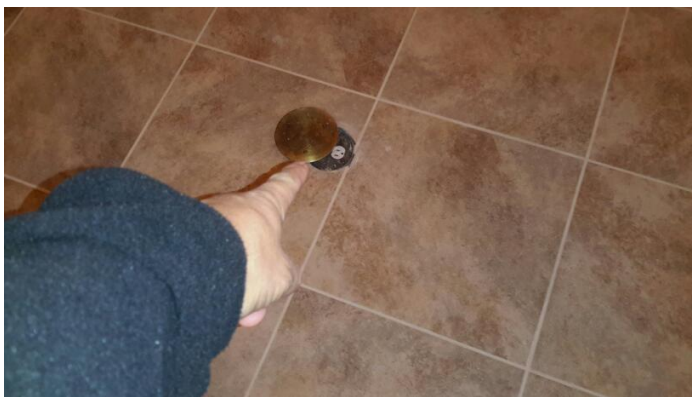
10.7 - There was a family room loose outlet cover located on the floor. This should be corrected by a certified contractor for safety reasons.

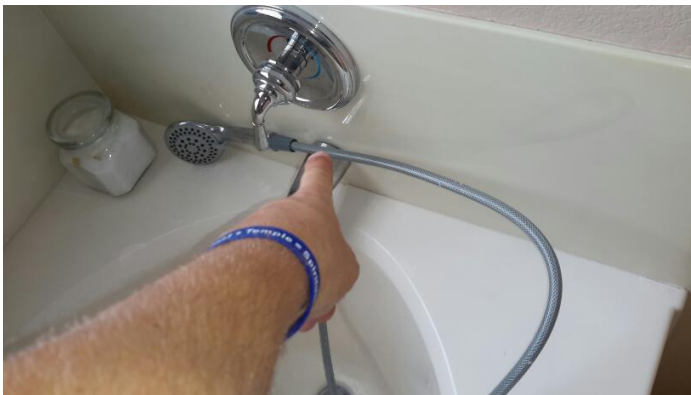
12.9 - In the master bathroom tub I recommend caulking or sealing around tub valves and faucets etc to help prevent moisture intrusion behind or into the walls. Monitoring these areas is also recommended to help ensure an adequate seal is in place.

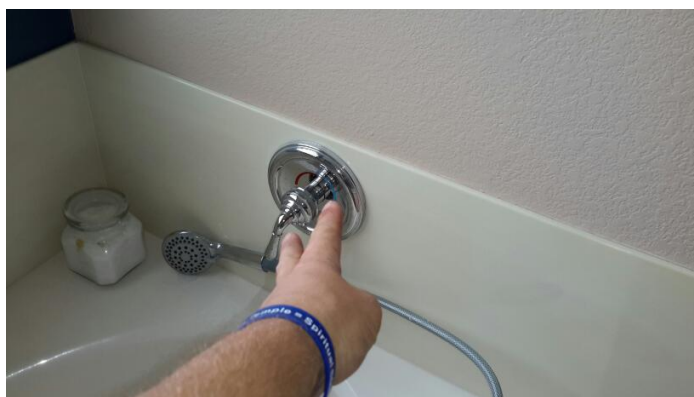
12.10 - The tub handles are loose and should be tightened up.

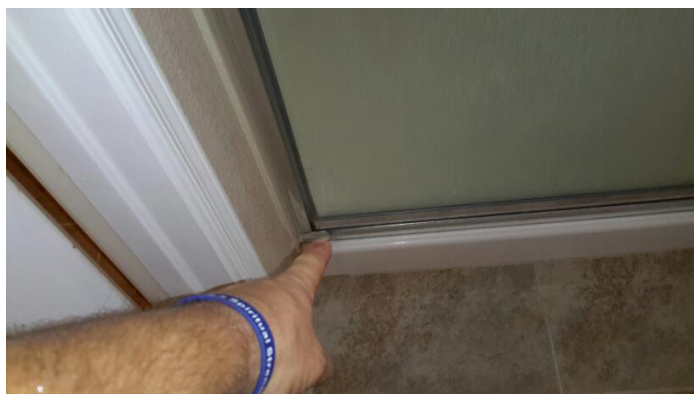
12.12 - In the master bathroom the shower door rubs and the sweep is missing or damaged, and should be serviced.

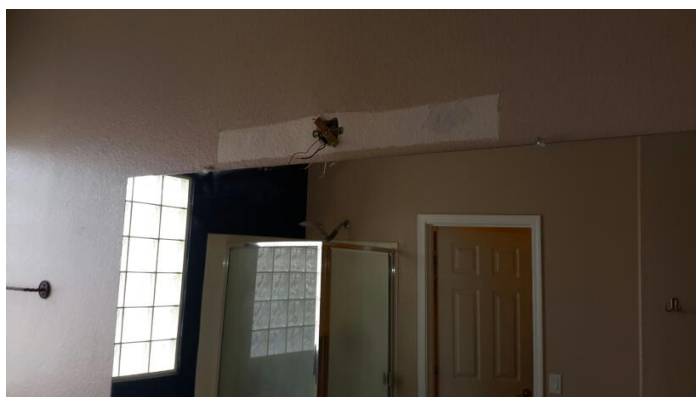
12.16 - In the master bathroom the light above the sinks was actively being replaced and you should check to make sure it was.

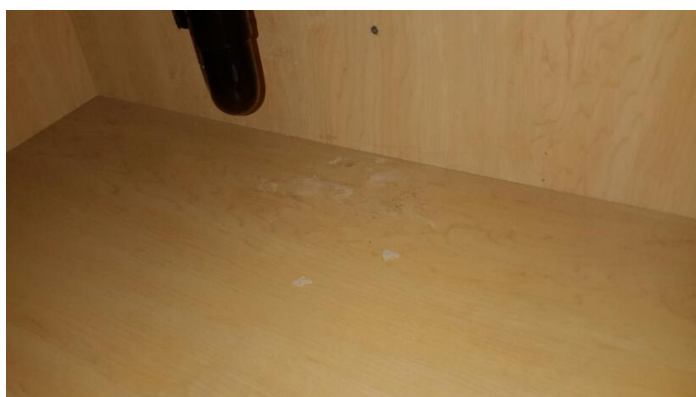
12.22 - The floor of the hallway sink cabinet is functional but slightly moisture damaged, which you may wish to see for yourself.

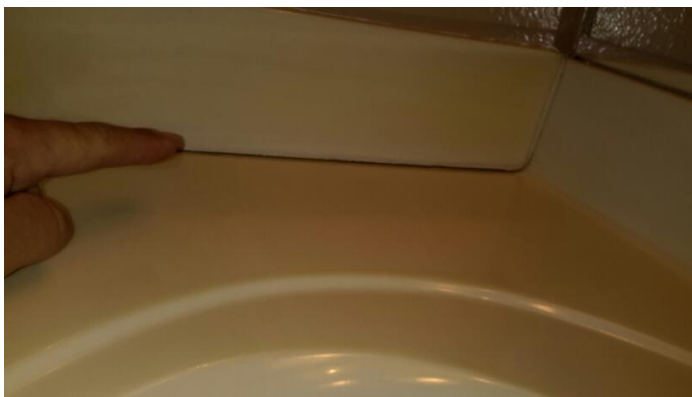
12.23 - In the hallway bathroom there is a separation between the sink and the countertop, which should be sealed to forestall moisture intrusion between the cabinet and the wall.

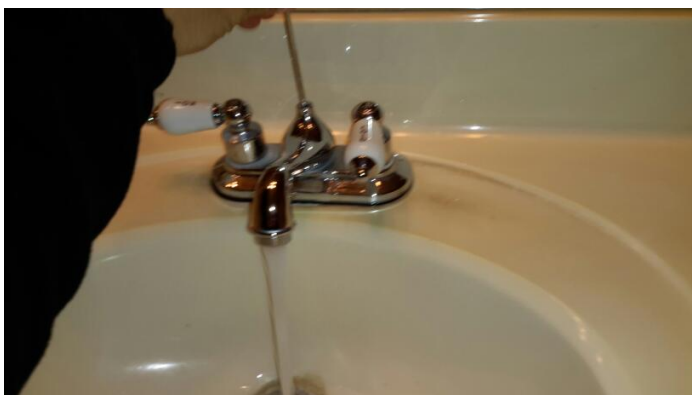
12.25 - In the hallway bathroom the mechanical sink stopper is incomplete and should be serviced or replaced .

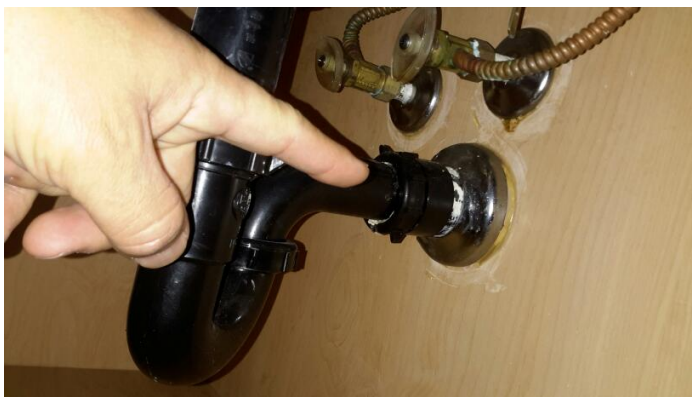
12.26 - In the hallway bathroom there are calcium deposits on the drain line that could indicate a slow or previous leak. However, this area was not wet or leaking during the inspection. I recommend service as necessary from a qualified technician, especially if you are concerned.

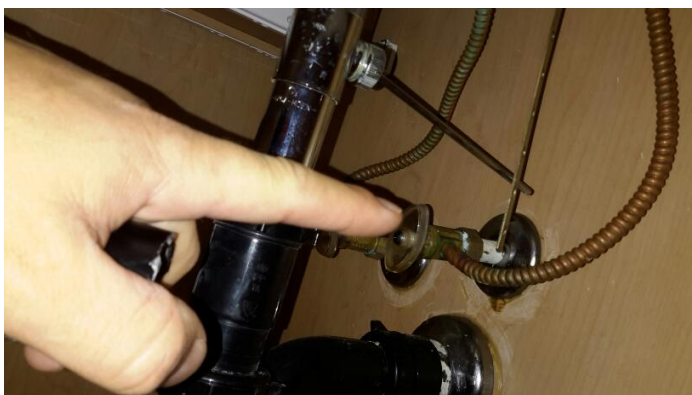
12.27 - Corrosion and/or mineral build-up was observed on the hallway bathroom Right shut-off valve . This corrosion or build-up may prevent the shut-off valve from working properly, especially if emergency shut-off is needed. I recommend a qualified, licensed plumber should evaluate and repair or replace this valve or connection as necessary.

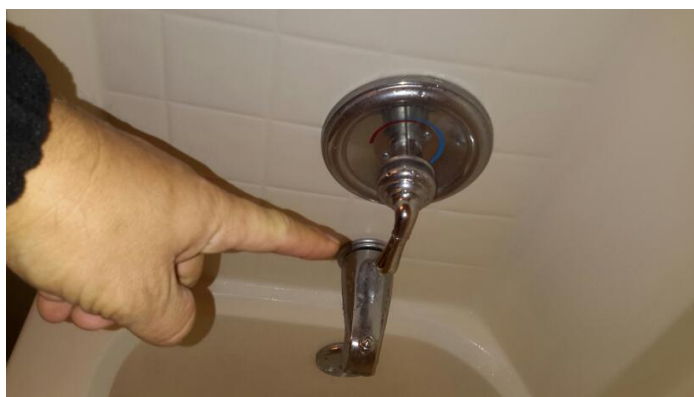
12.29 - In the hallway bathroom the I recommend caulking or sealing around shower valves and faucets etc to help prevent moisture intrusion behind or into the walls. Monitoring these areas is also recommended to help ensure an adequate seal is in place.

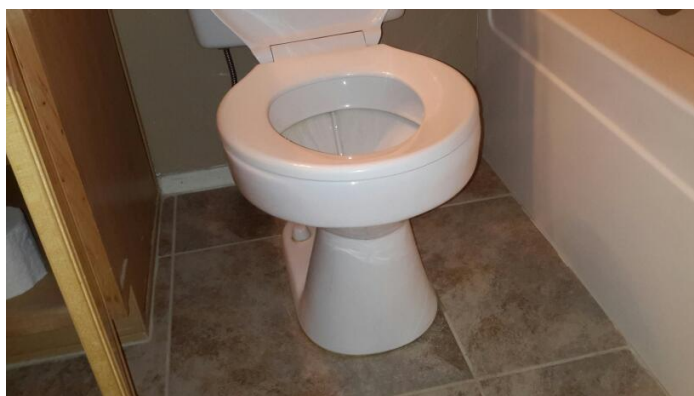
12.30 - In the hallway bathroom the toilet is functional, but loose on the floor and should be secured by a qualified technician, for safety reasons and to prevent possible damage or leaking from around the toilet.
