**Buyer's Choice Home Inspections**  
**The Best Home Inspection At The Best Price**  
7403 w Fargo Dr.  
Peoria, AZ 85382  
Tel 480-250-1136 Mobile (480) 250-1136  
Web [www.inspectazhomes.com](http://www.inspectazhomes.com) Email [info@inspectazhomes.com](mailto:info@inspectazhomes.com)

## Confidential Inspection Report

**15848 N 136th Ln**  
**Surprise, AZ 85374**

**02/18/2017 08:00 AM - 11:30 AM**

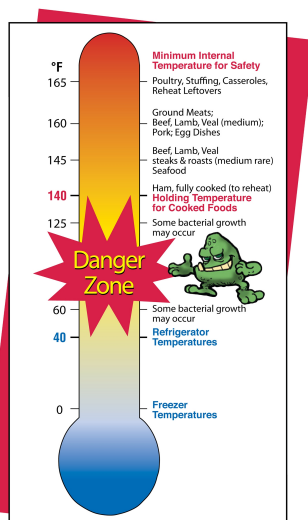
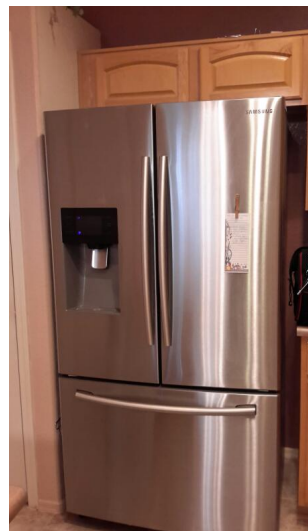
1.2 - The fridge was ok and achieved fridge and freezer temperatures. This is a limited courtesy fridge inspection you should ask the sellers about its full operation. You should make sure to set your fridge at appropriate temps.

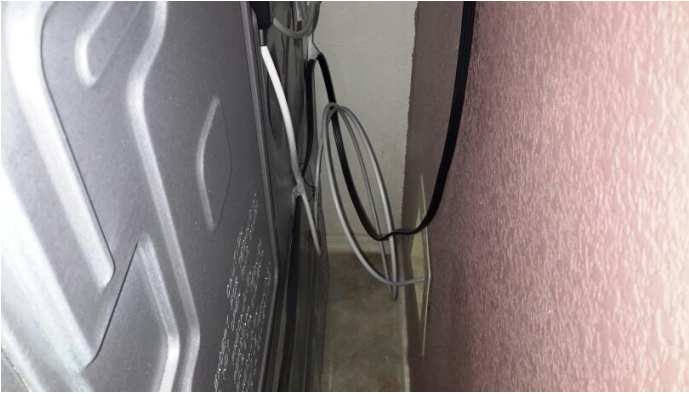
1.3 - The refrigerator water line appears to be in good condition and was not leaking during the inspection. I did not test it or try to run water through it as part of this inspection.

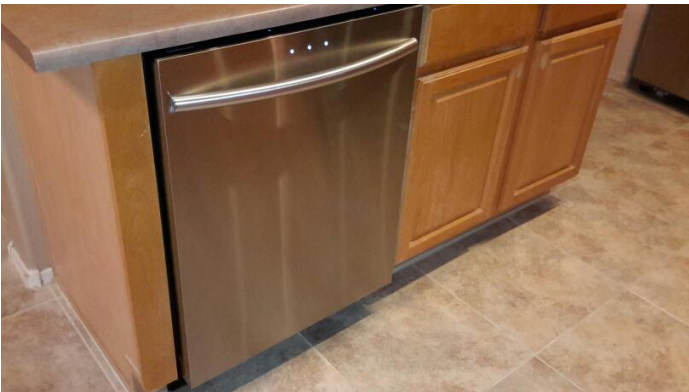
1.4 - The dishwasher is functional, completes an entire cycle, drains properly and no leaking was noted.

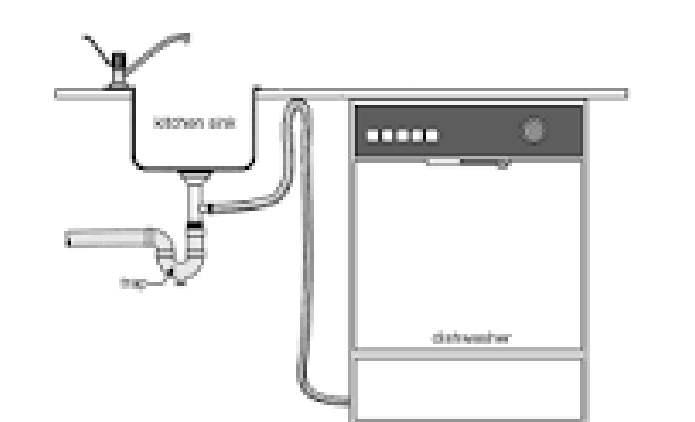
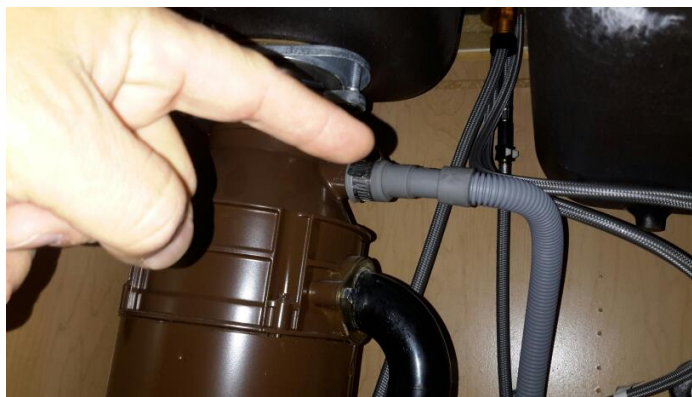
1.5 - The dishwasher does not have a proper high loop in the drain line at the garbage disposal and one should be added. The drain line should be raised 4-6 inches above the garbage disposal inlet to create a high loop that should help prevent the possibility of contaminants back flowing from the disposal into the dishwasher and to especially avoid unpleasant smells.

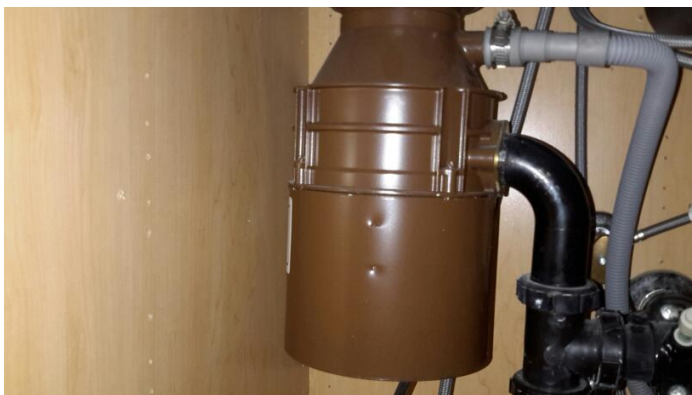
1.11 - The garbage disposal was functional during the inspection and responds to its controls. No leaking was noted at this time. NOTE: Garbage disposals commonly freeze up or stop working from lack of use, wear and age.

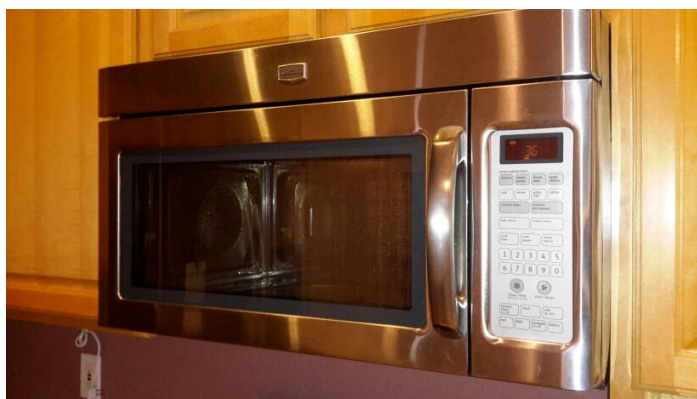
1.12 - The built-in microwave was functional during the inspection, but I did not test it for leakage, which would require a specialized instrument. However, their power diminishes over time, and the specific measurement of the microwaves, as well as their containment within the unit, requires specialized instruments, which is beyond the scope of our service.

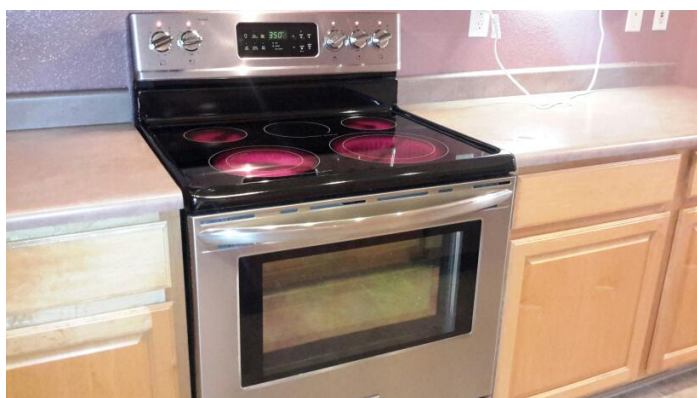
1.13 - The electric oven is functional and both bake and broil work on demand.

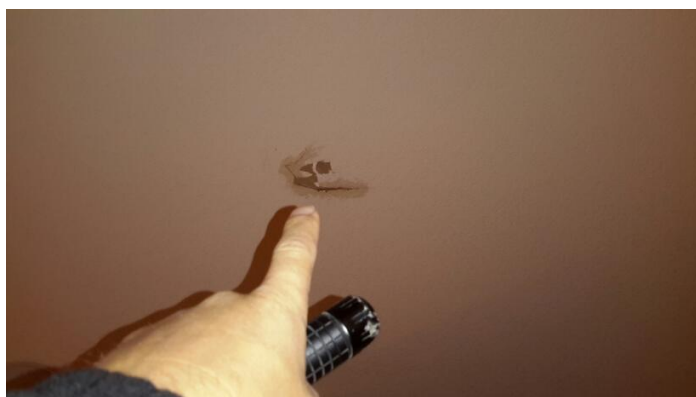
1.17 - The walls or ceiling have minor cosmetic damage (scuffs, scrapes, nail holes etc) that you should view yourself and correct as desired.

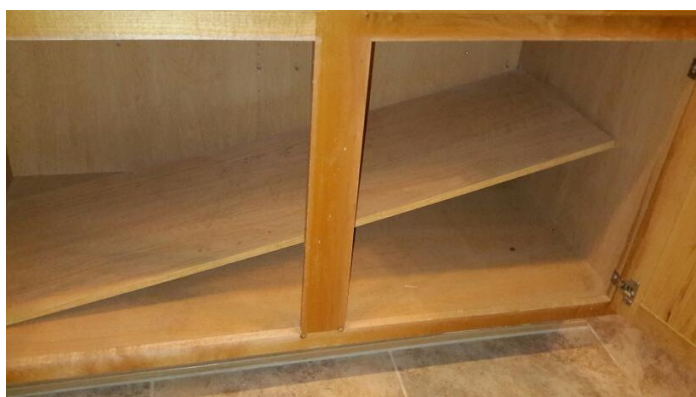
1.21 - A cabinet shelf needs hardware to sit correctly in the cabinet.

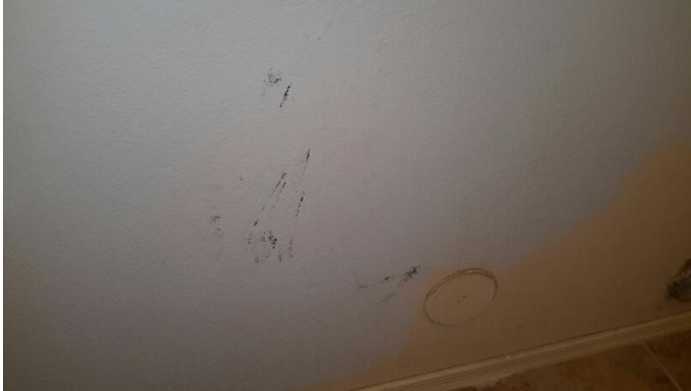
2.5 - The walls have typical and minor cosmetic damage (scuffs, scrapes, scratches, small holes etc.) that you should view for yourself and correct as desired.

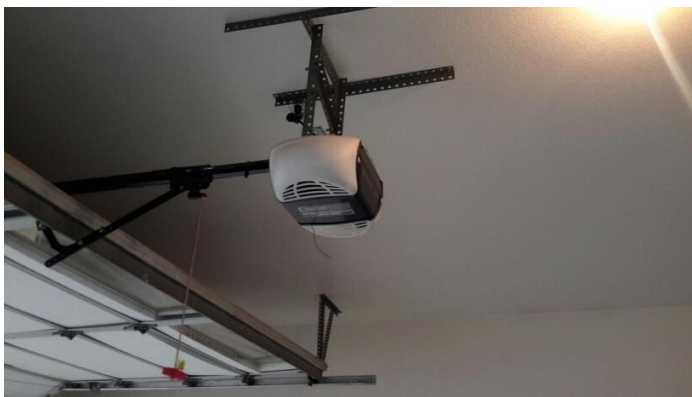
3.10 - The automatic garage door opener is functional and reverses on demand when the safety lights are obstructed.

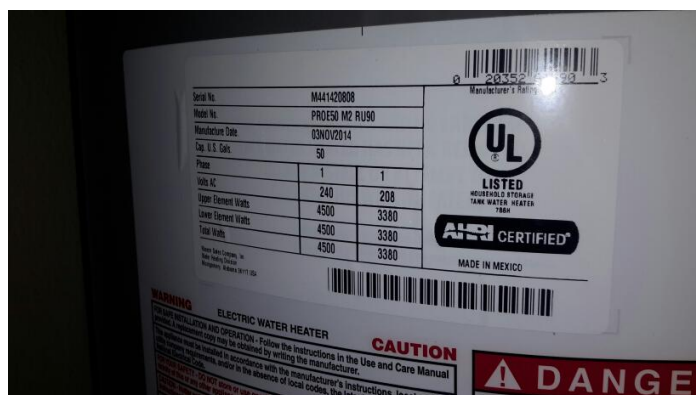
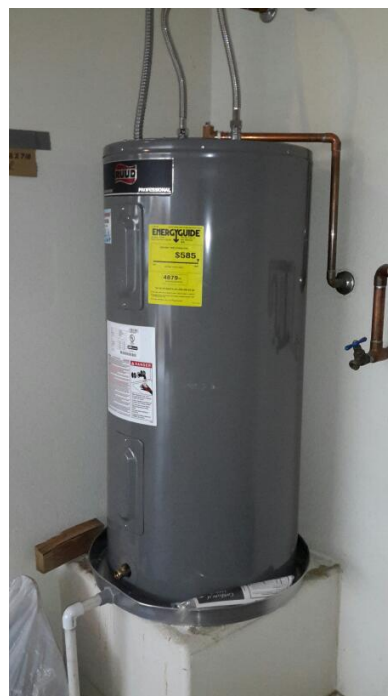
4.2 - Hot water is provided by a 2014, 50 capacity, Ruud brand electric water heater located in the garage.

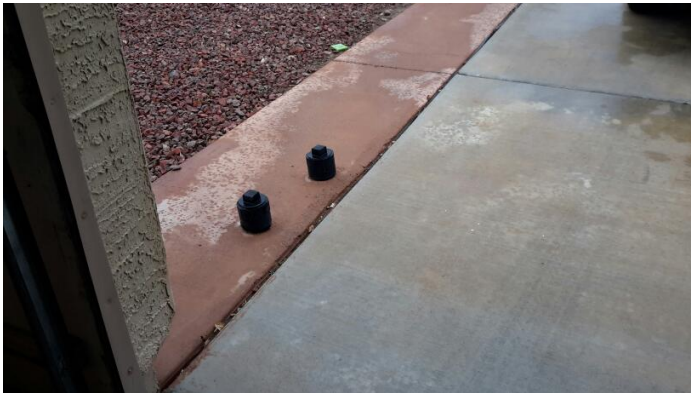
4.10 - The clean outs for sewer were in front of the house.

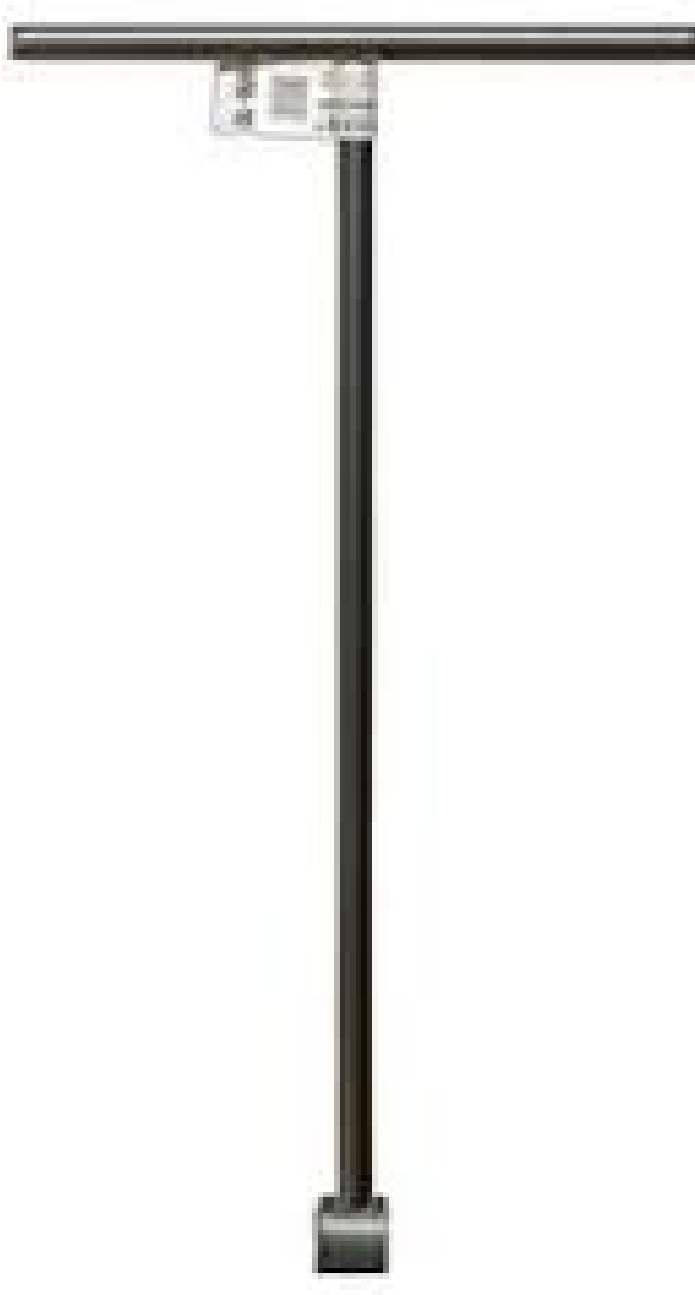
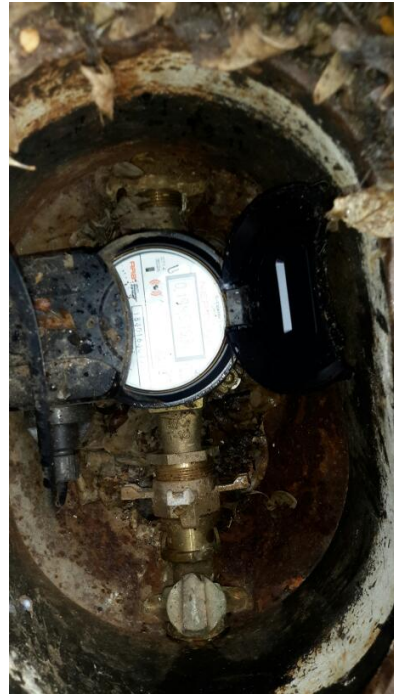
4.11 - The street or city water shut off valve is located in the front yard near the street under a cover. I observed it for a short while and noticed that the meter was not spinning or moving. This indicates that there is not any water leaking at the property. This is also a good way to locate if there is a possible underground water leak. However, this is not an exact determination and further evaluation from a qualified plumber is recommended, before the close of escrow, especially if you desire more information or are concerned about the possibility of an underground water leak. I recommend getting a emergency water key from a hardware store in case of emergency.

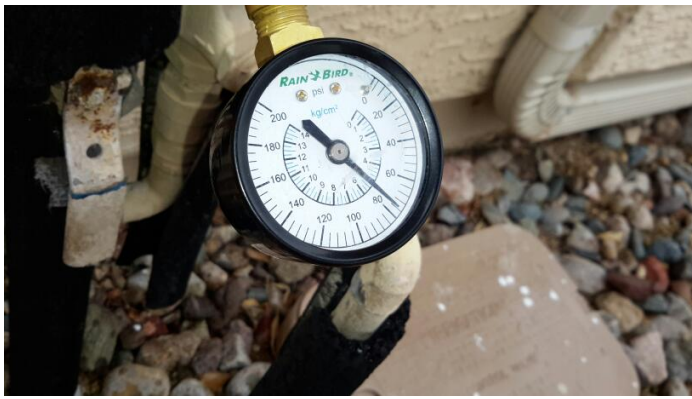
4.12 - The pressure at the street is under 80psi (currently 72 psi) and a regulator is not required on the plumbing system.  
A pressure range of 40 psi to 70 psi is usually considered a good and safe range.

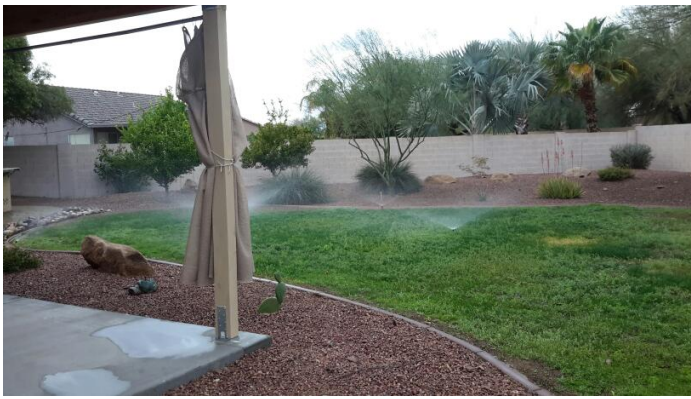
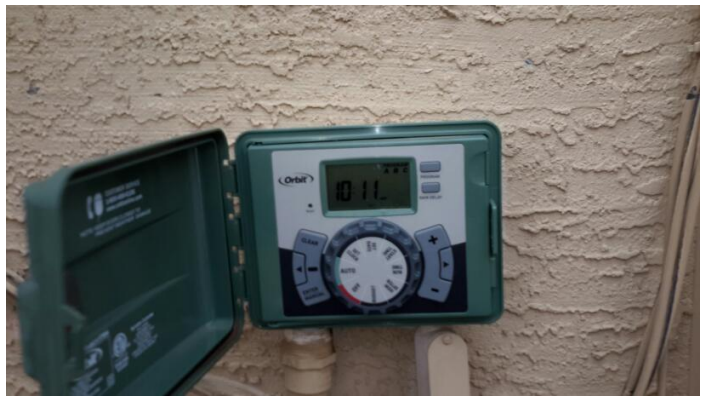
4.15 - The drip and sprinkler irrigation system works on demand and responds to the irrigation control valves located in the ground box. I was unable to view each and every drip head due to visual limitations. I tested through the automatic irrigation timer, if present. Further review of the system by a qualified landscape service is recommended for more information or demonstration before the close of escrow.

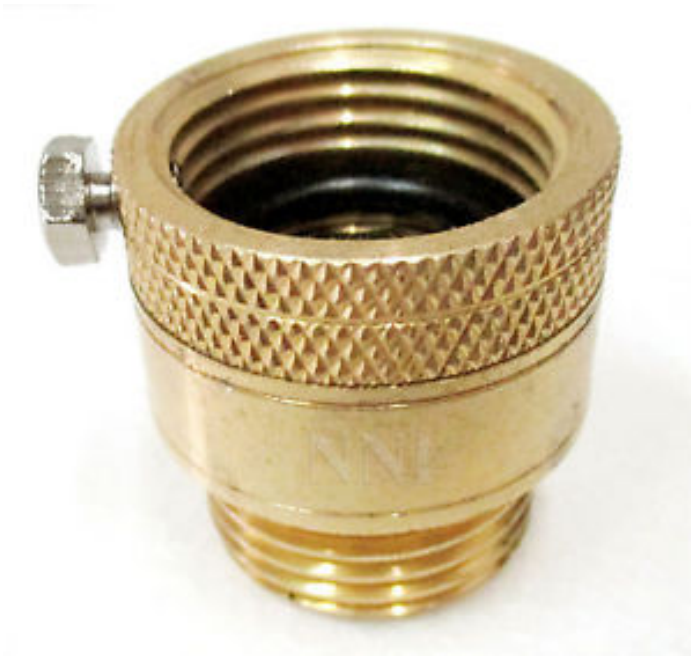
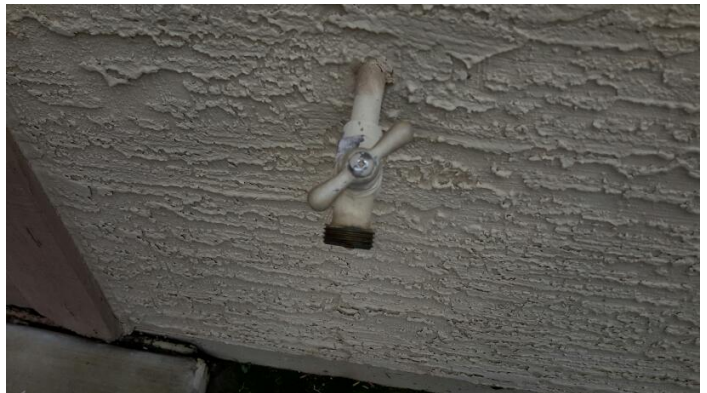
4.16 - The hose bibs that I tested are functional, but do not include anti-siphon valves. These valves are relatively inexpensive, are required by current standards. However, I may not have located and tested every hose bib on the property.

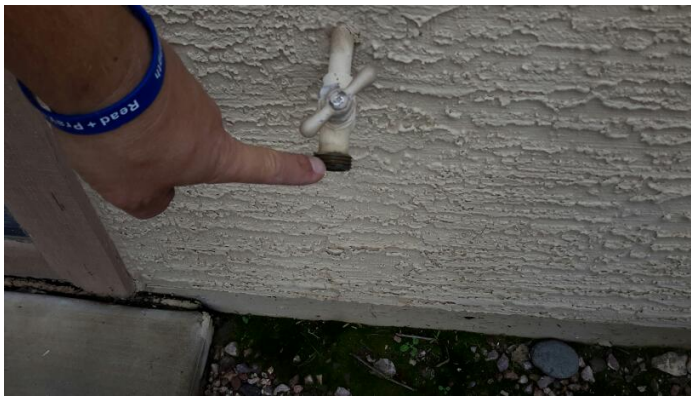
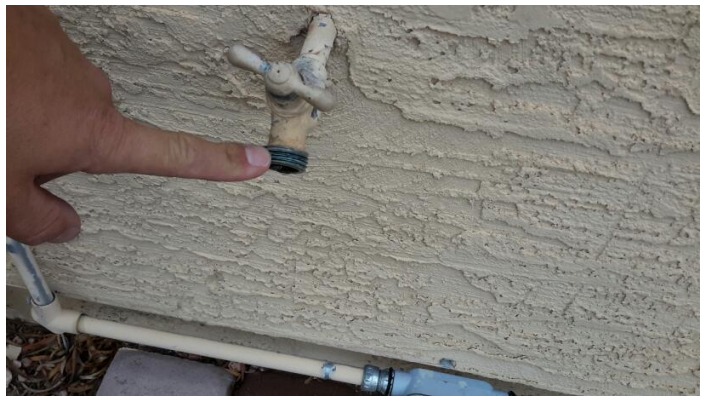
4.17 - A hose bib at the right and left is dripping and needs service.

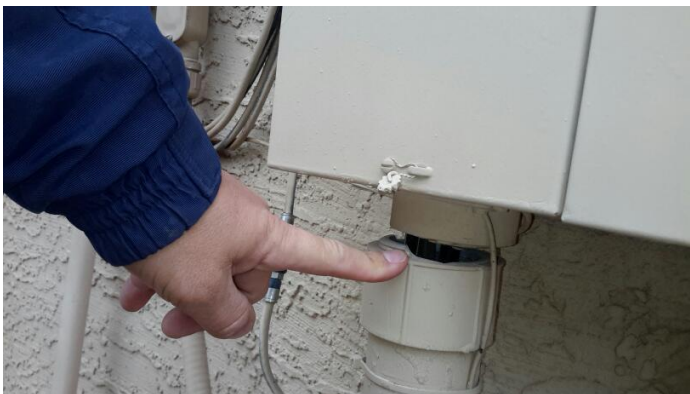
6.3 - The conduit that covers the main conductor lines is cracked, beneath the panel box, which leaves exposed live wires. Further evaluation is recommended for safety reasons

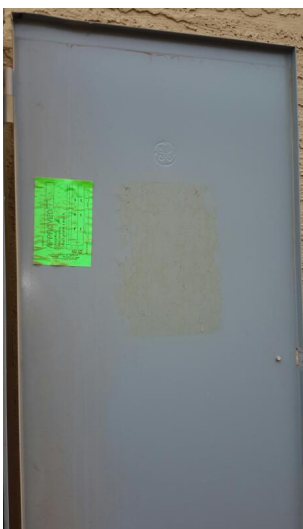
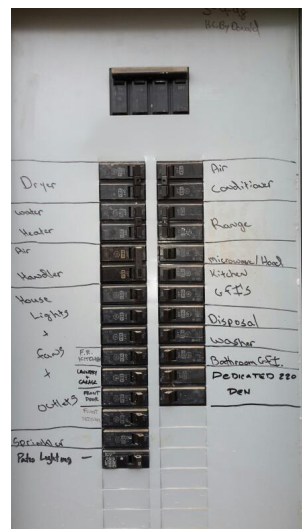
6.4 - There is no manufacturers label present which prevents me from determining the correct or accurate ratings. However it appears to be a 200 amp general breaker panel located on the left side of the home.

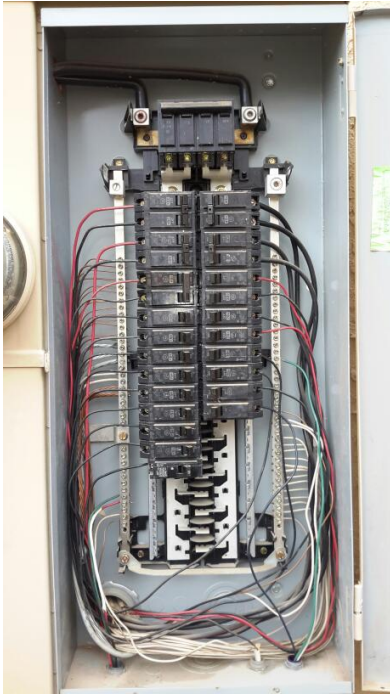
6.8 - The visible portions of the wiring have no deficiencies and copper wiring was noted.

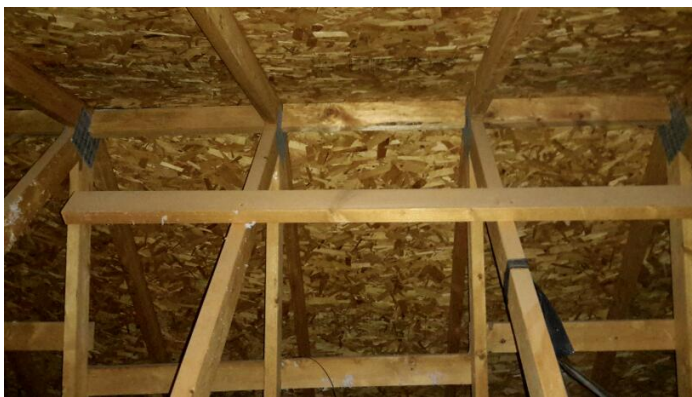
7.4 - The visible portions of the oriented strand board roof or OSB decking are in acceptable condition and should conform to the standards of the year in which they were installed.

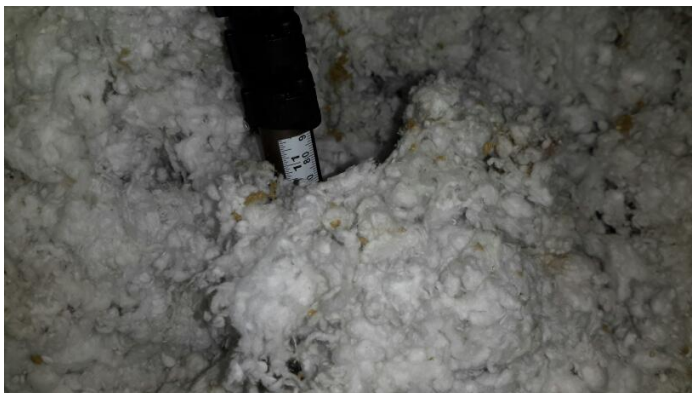
7.10 - The attic floor is adequately insulated with blown loose cellulose but not to a maximum standard. I observed approximately 11+ inches in various floor areas which should provide a more than minimum insulation rating of R-30 as required. Insulation prevents viewing some attic areas.

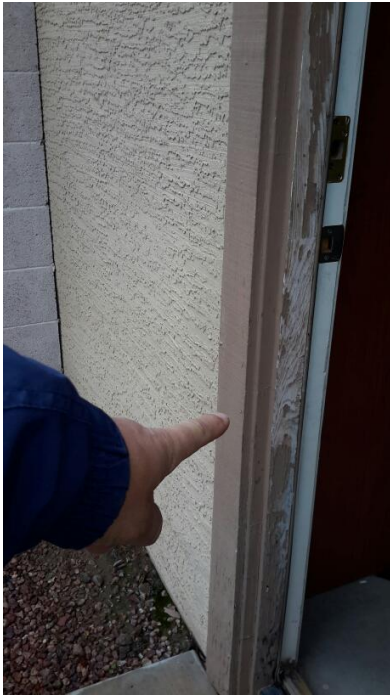
8.5 - Sections of the fascia board or wood trim around the garage side door residence are slightly weathered, and should be serviced as necessary to prevent further deterioration. Service such as scraping, repainting and sealing.

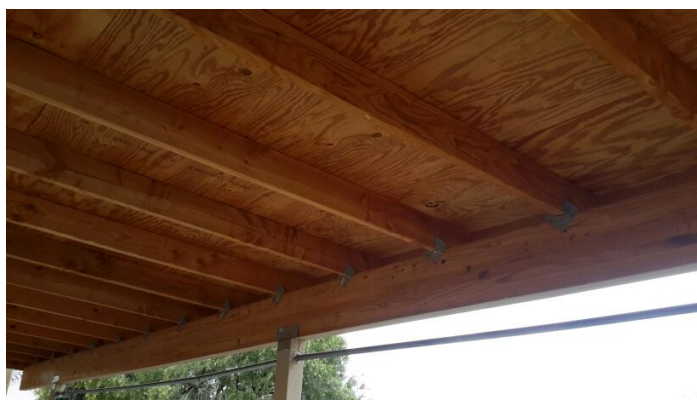
8.7 - The exposed wood under the patio should be painted to protect it

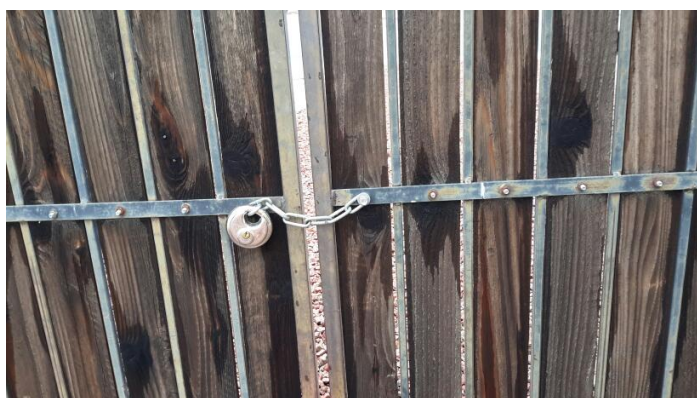
8.8 - The gate was locked during the inspection and could not be opened.

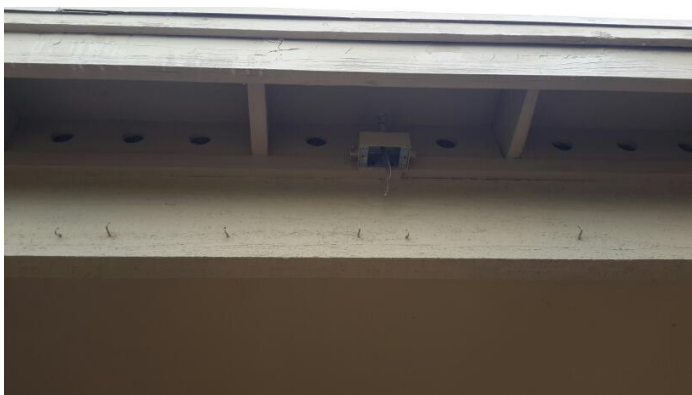
8.12 - There is a junction box with exposed wiring by the back patio which should be properly capped and sealed to prevent shock or fire.

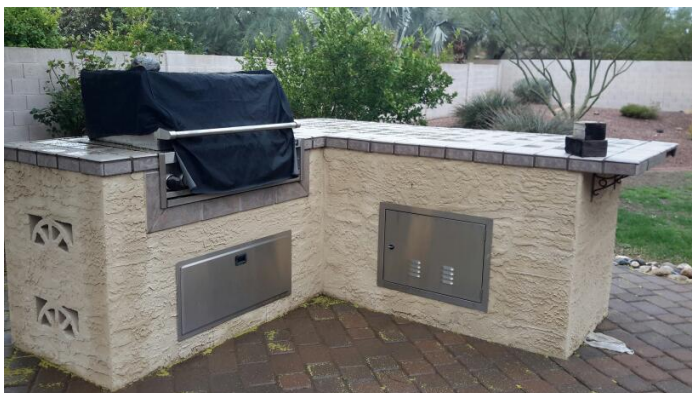
#### Barbecue Area

8.13 - Picture of BBQ area and disclosure statement

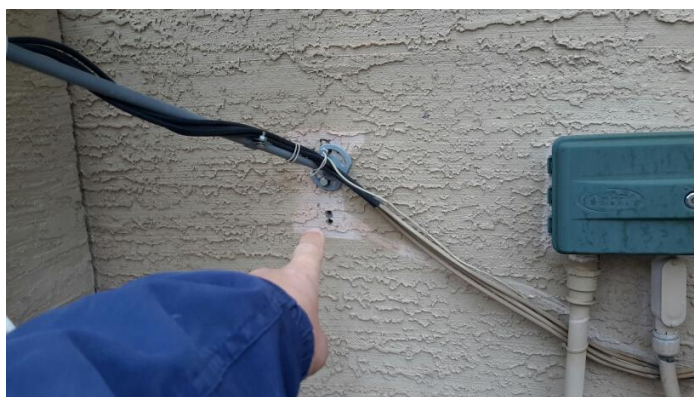
8.21 - There are a few small maintenance dings in the stucco that need to be patched. They were located on the south side,

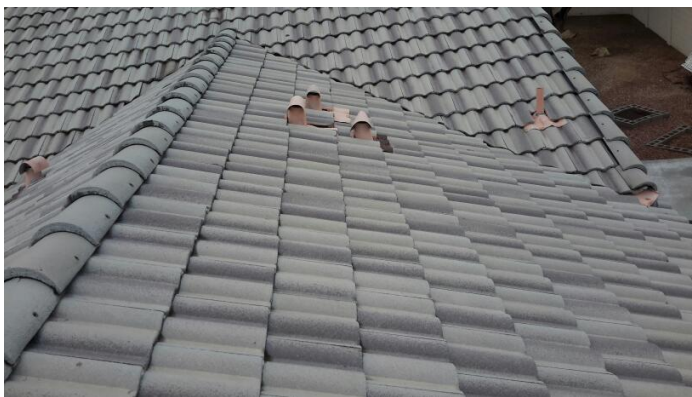
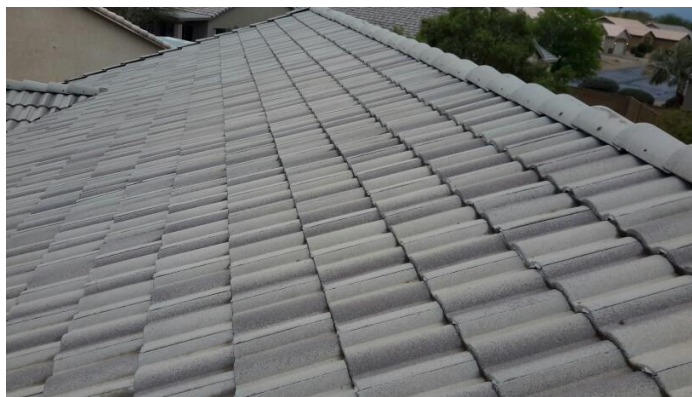
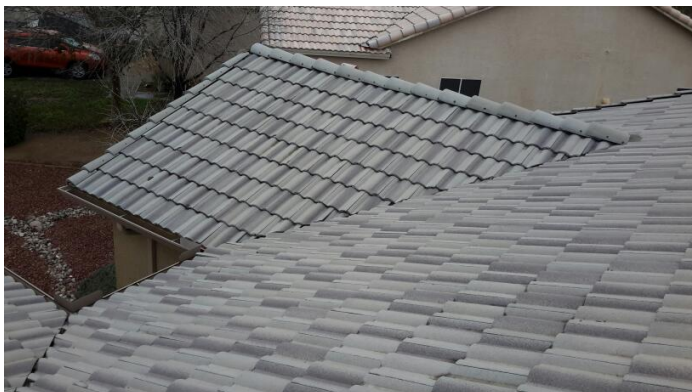
9.2 - The roof and its components were evaluated by walking on its surface.

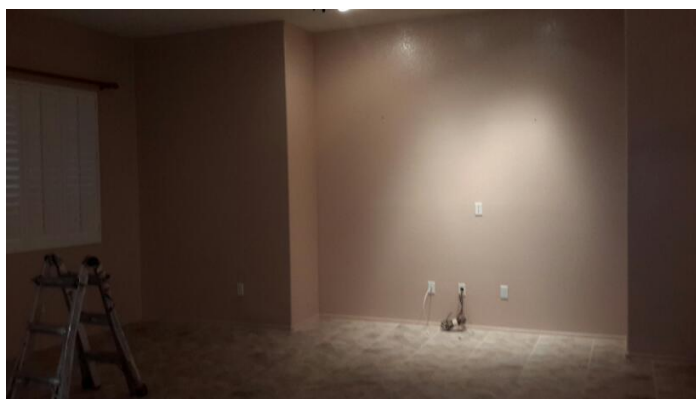
#### Family Room Picture

10.1 - Picture of Family Room.

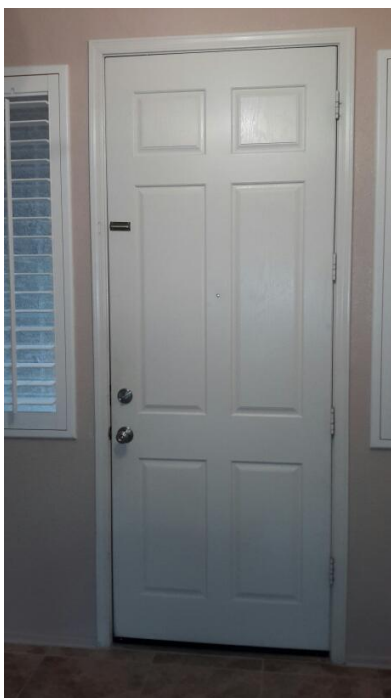
### Main Entry Picture

10.8 - Picture of Main Entry

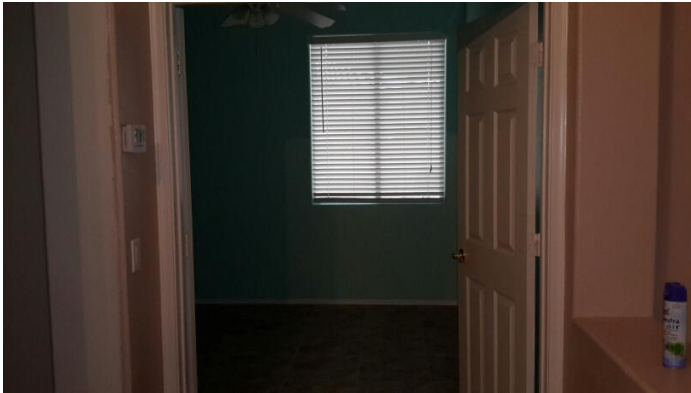
#### Office or Library Picture

10.16 - Picture of Office or Library.

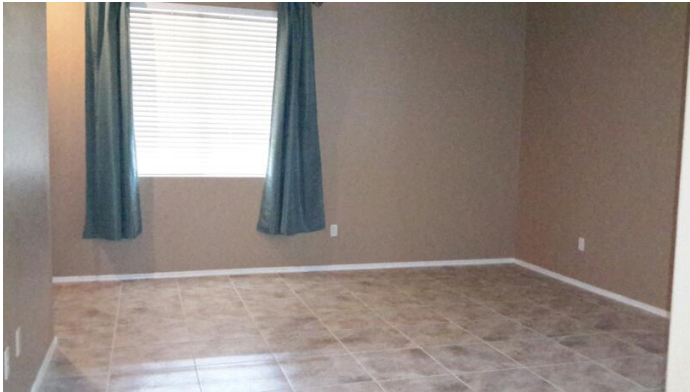
### Master Bedroom Picture

#### 13.1 - Picture of Master Bedroom

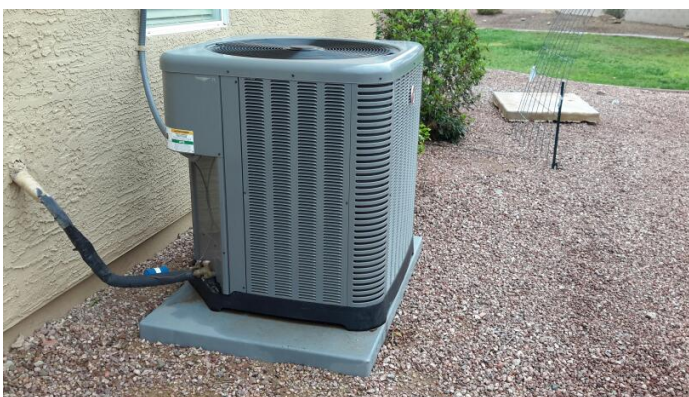
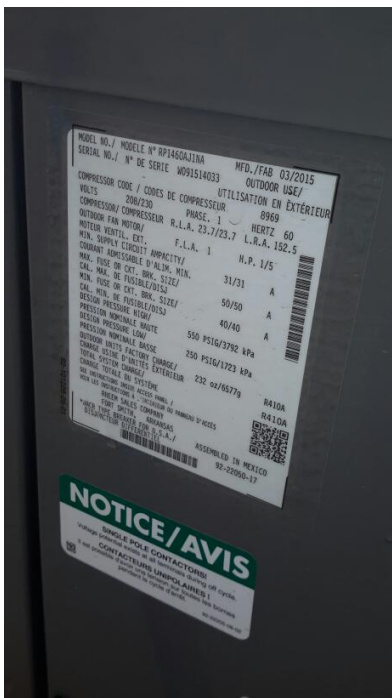
### Age & Location

14.1 - Central heat and air-conditioning are provided by a 2015, 5 total ton capacity, Rheem brand heat pump located in the backyard. The evaporative coil/air handler is located in the attic.

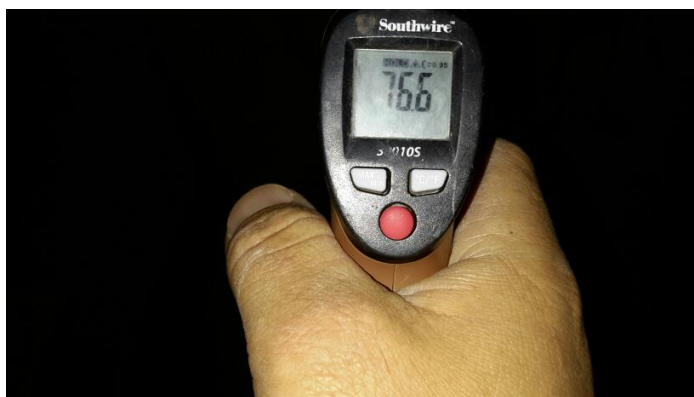
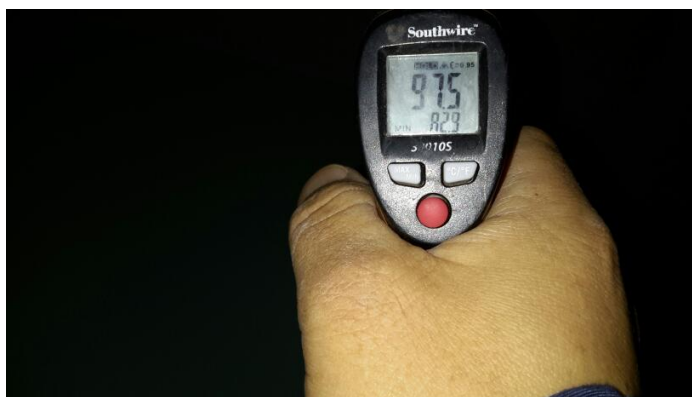
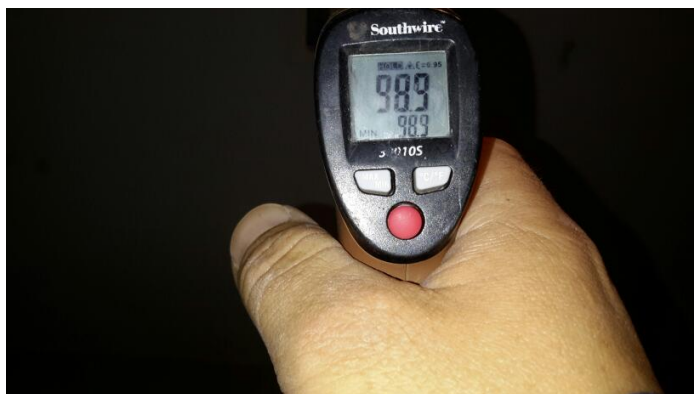
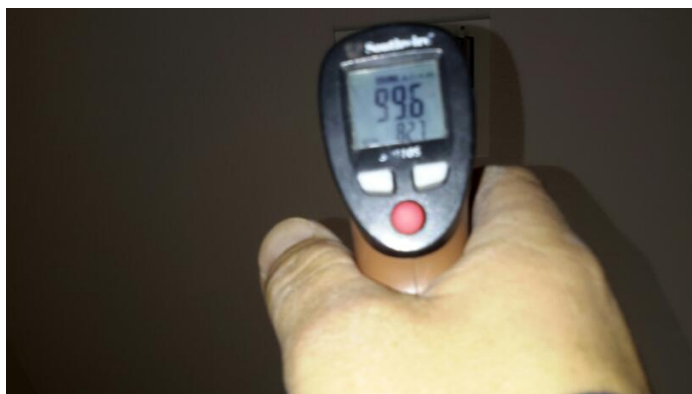
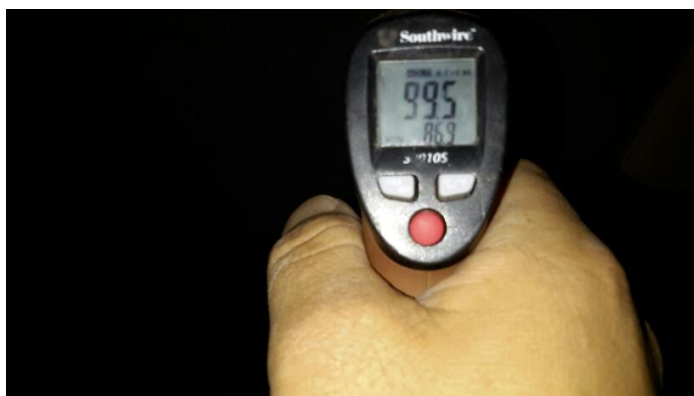
## Differential Temperature Readings

14.3 - The heating responded and achieved an acceptable differential temperature split between the air entering the system and that coming out. 22.9 degrees difference noted with a split of 99.5 degrees at the supply air registers and 76.6 degrees at the return.

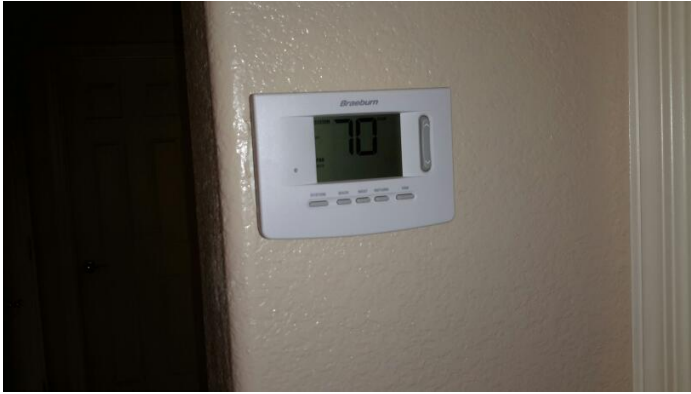
### Thermostats

14.11 - The thermostat was located near the kitchen.

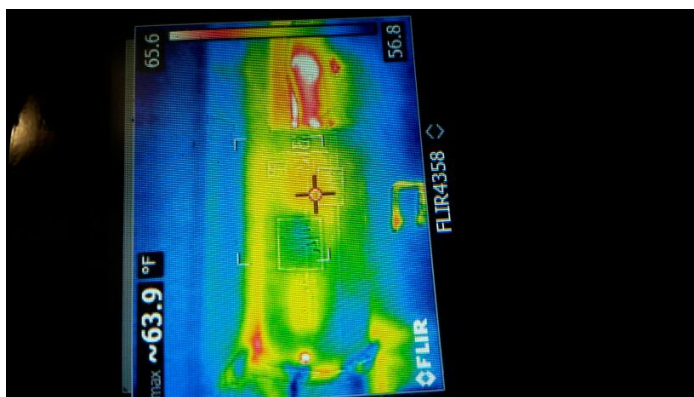
#### Water Heater

15.2 - This thermal image of the Electric water heater appears to be working properly, with no signs of leaking.

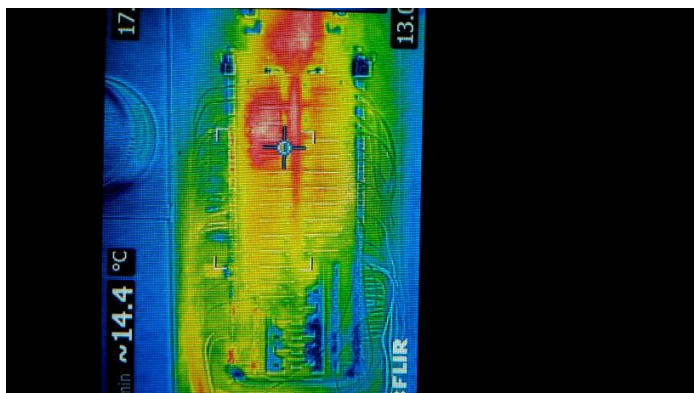
#### Electrical

15.3 - The thermal image of the electrical breakers and electrical within the panel are in use but within normal temperature range.

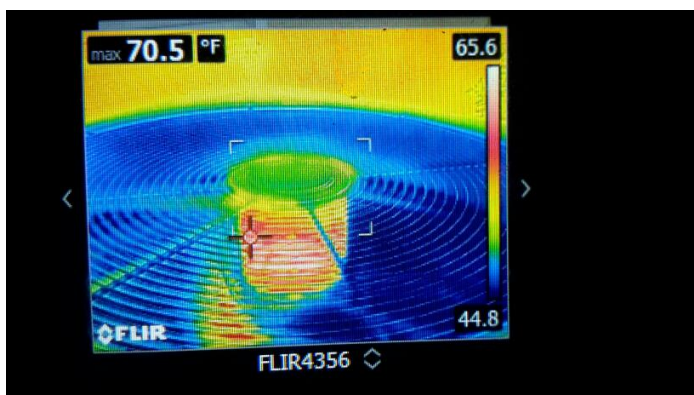
#### Air Conditioner Coil

15.4 - The Air conditioner(s) were scanned with the thermal camera and it appears to be operating normal with no signs of the fan bearings overheating.

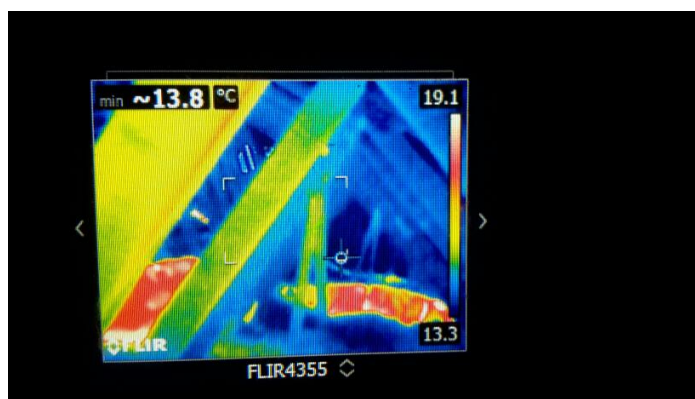
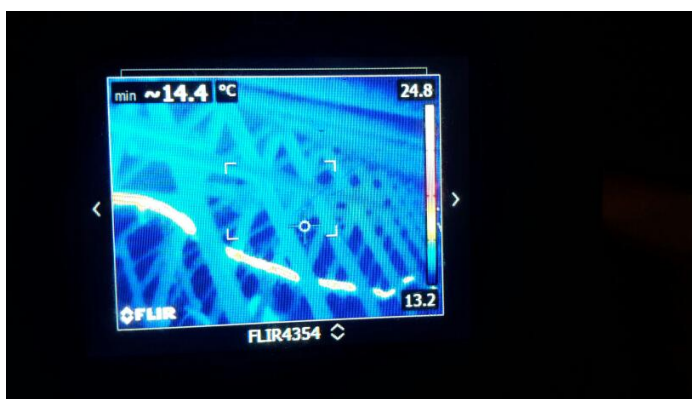
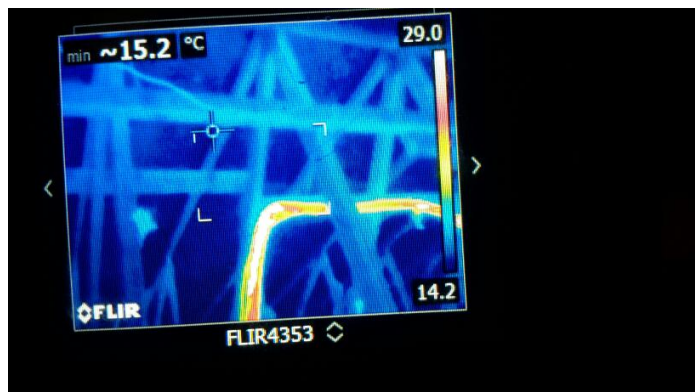
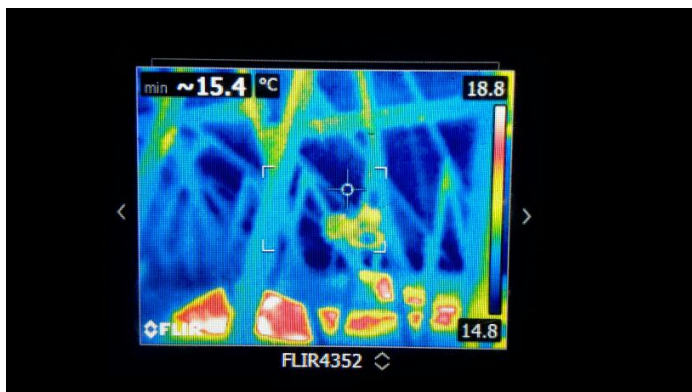
#### Attic

15.5 - Components within the attic was scanned by thermal camera and they appear to all be working as normal, with no immediate signs of rodents, abnormal leaking HVAC pipes, wet spots etc.

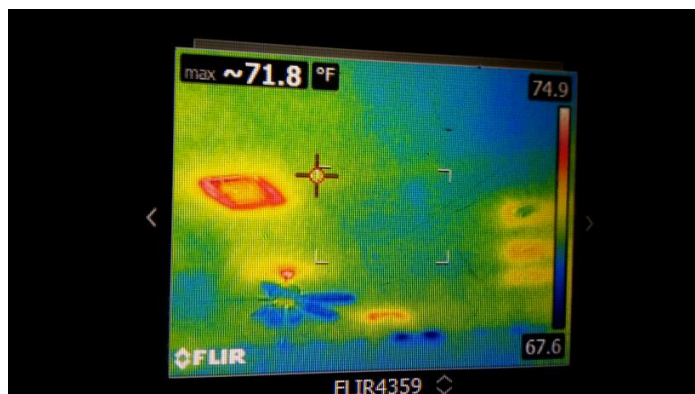
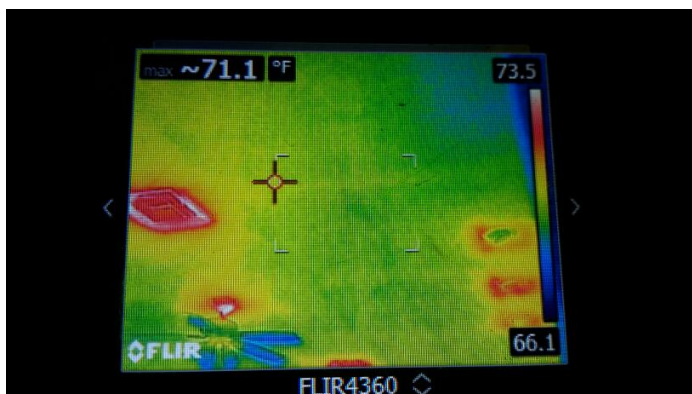
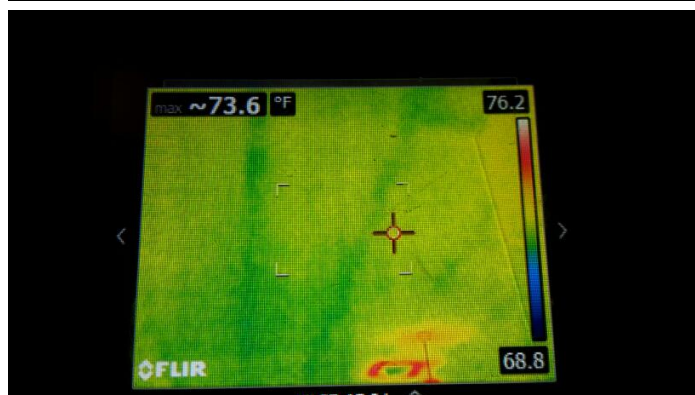
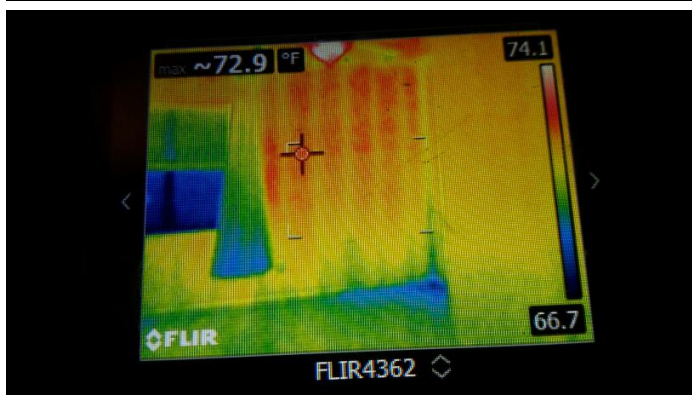
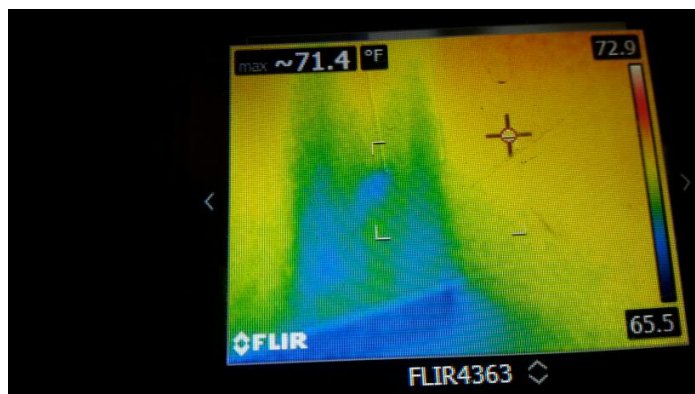
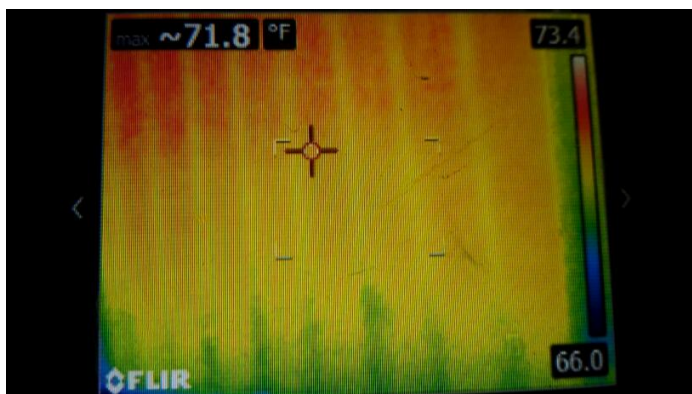
#### Walls- Basic

15.6 - Various places of the walls were scanned with a thermal camera for plumbing leaks and voids in insulation. Unless noted there were no leaks found during the inspection or abnormal voids in the insulation
